(11)Publication number : 10-096705

(71)Applicant : TOKAI CARBON CO LTD

(54) NON-DESTRUCTIVE EXAMINATION METHOD FOR CARBON FIBER REINFORCED CARBON COMPOSITE MATERIAL

(54)【発明の名称】 炭素繊維強化炭素複合材の非破壊検査法

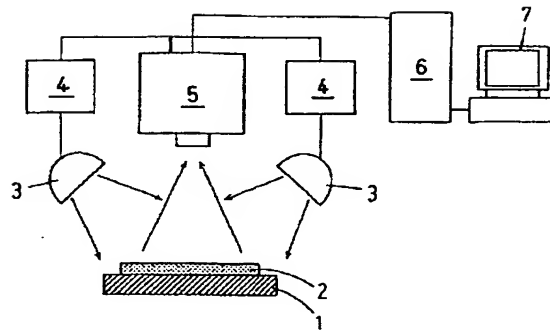
【図1】

【図1】本発明に係るC/C複合材の欠陥部位を検出する非破壊検査法に用いられる装置を例示した全体構成図である。

- 1 試料台
- 2 C/C複合材
- 3 フラッシュランプ
- 4 ランプ用電源
- 5 赤外線サーモグラフ装置
- 6 演算処理装置（CPU）
- 7 画像表示装置

図1は本発明の非破壊検査法に用いた装置を例示した全体構成図である。図1の装置において、試料台1の上には被検査材料であるC/C複合材2が載置され、試料台1の斜め上方には高出力のフラッシュランプ3が2個配置されており、ランプ用電源4により高出力で熱線がC/C複合材2の表面に照射される。フラッシュランプ3の熱線照射に同期させてC/C複合材2からの放射エネルギーが、試料台1の真上に配置された赤外線サーモグラフ装置5に入力され、演算処理装置6(CPU)に高速で熱画像データとして入力する。入力された熱画像を演算処理装置6(CPU)で再生し、画像表示装置7に熱画像が表示され、C/C複合材2の表面温度分布に関する時系列情報が画像表示される。

【0019】この試料A～Cを図1の試料台1の上に載せ、フラッシュランプ3により一瞬熱線を照射して瞬時に60～70℃の温度に加熱した。その後、試料A～Cからの放射エネルギーを赤外線サーモグラフ装置5により演算処理装置6（CPU）に画像入力し、再生して画像表示装置7にその表面温度分布を画像表示して、その
